SHASTA LAKE WATER RESOURCES INVESTIGATION TECHNICAL REPORT

Volume I. Natural Resource Characterization

Draft–July 2004

Prepared for:
Bureau of Reclamation

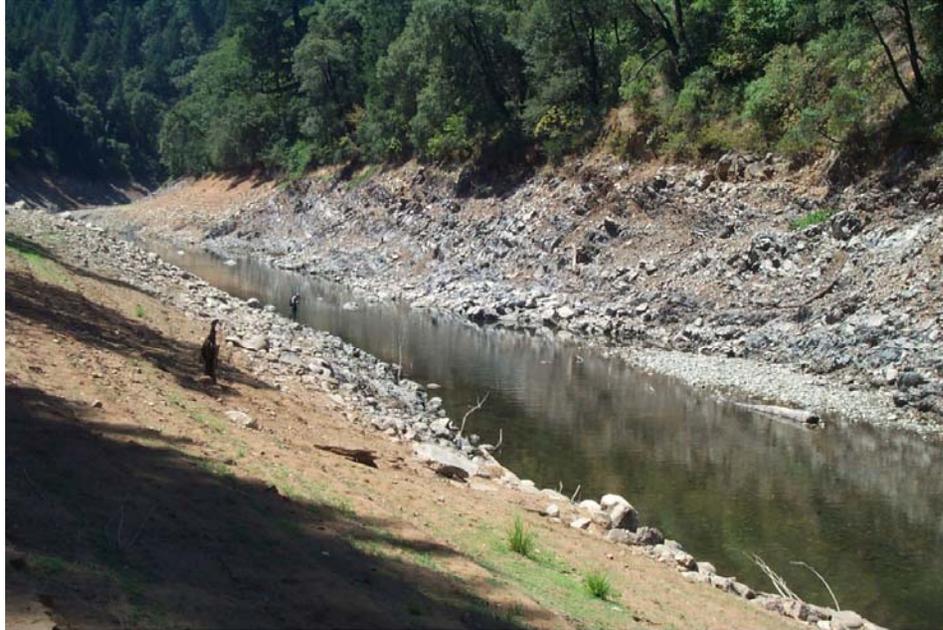
Photo SQC-1

View downstream from right bank nr reservoir high water mark to Squaw Creek nr LP STA 0+00 ft, July 14, 2002.

Reach 1 is a 0.4 percent slope bedrock and boulder-bedded channel extending from Shasta Lake up to Station 12+94 feet. The entire 35- to 45-ft wide active channel width in the lower 400- to 500-ft long section of Reach 1 (photo SQC-1) is alluviated and mildly sinuous with shallow plane-bed conditions, alternating bars, and highly embedded substrates typical of conditions suggested in a review of the digital orthophotographs of Squaw Creek used in the Atlas. A pebble count of the bar surface at Station 1+30 ft shows some similarity to other pebble counts measured throughout the reach. The exception was the addition of fine sediments dominating the surface matrix and veneer (**Table 3-31**). Massive alluviation in the downstream portion of Reach 1 accounts for its locally decreased channel bed slope compared to likely pre-Shasta Lake conditions. Cross-Section 1 (**Figure 3-72**) and Cross-Section 2 (**Figure 3-73**) illustrate channel form and dimensions in Reach 1 (Photo SQC-2). There was no riparian vegetation present in Reach 1, and the bed and bar materials were moderately to highly embedded with fine matrix and veneer materials. Reach 2 is a 1.3 percent slope bedrock and colluvial boulder-dominated reach extending upstream to a massive colluvial boulder deposit and resulting cascade-pool section near Station 22+96 feet. Cross-Section 3 and Cross-Section 4 (**Figure 3-74**) illustrate channel form and dimensions in Reach 2. There was no riparian vegetation present in Reach 2, and bar materials were moderately to highly embedded with fine matrix and veneer materials.

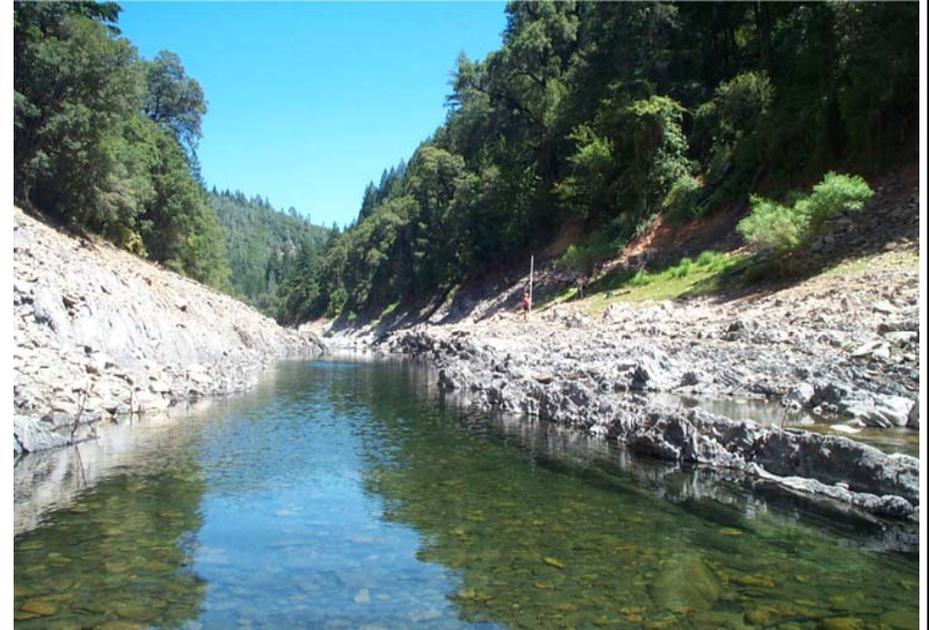
Photo SQC-2

View downstream from mid-channel nr LP STA 9+60 ft, Squaw Creek, July 14, 2002.

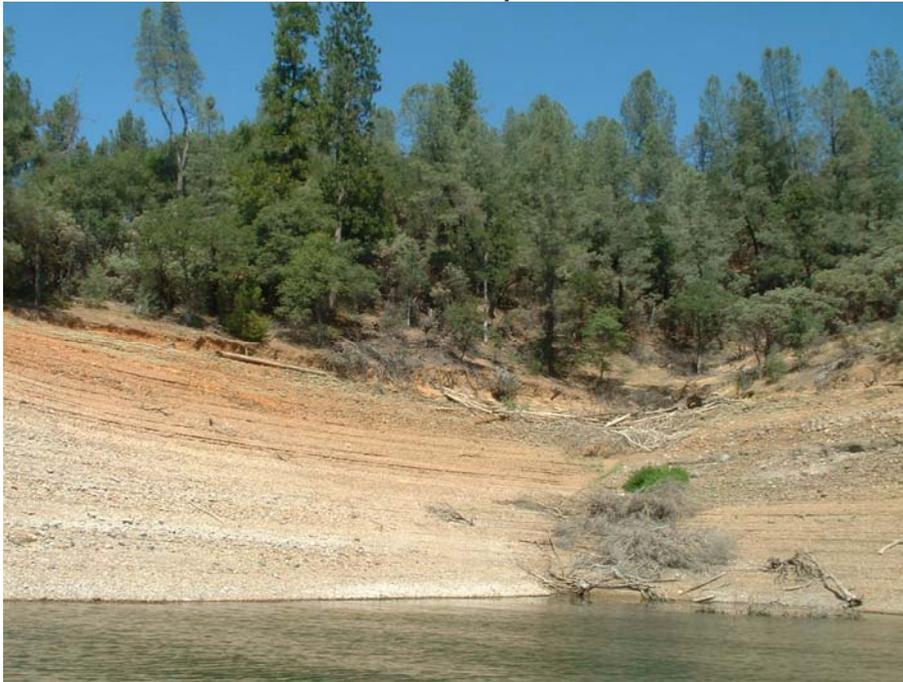
Photo Example 1

Low Severity Erosion

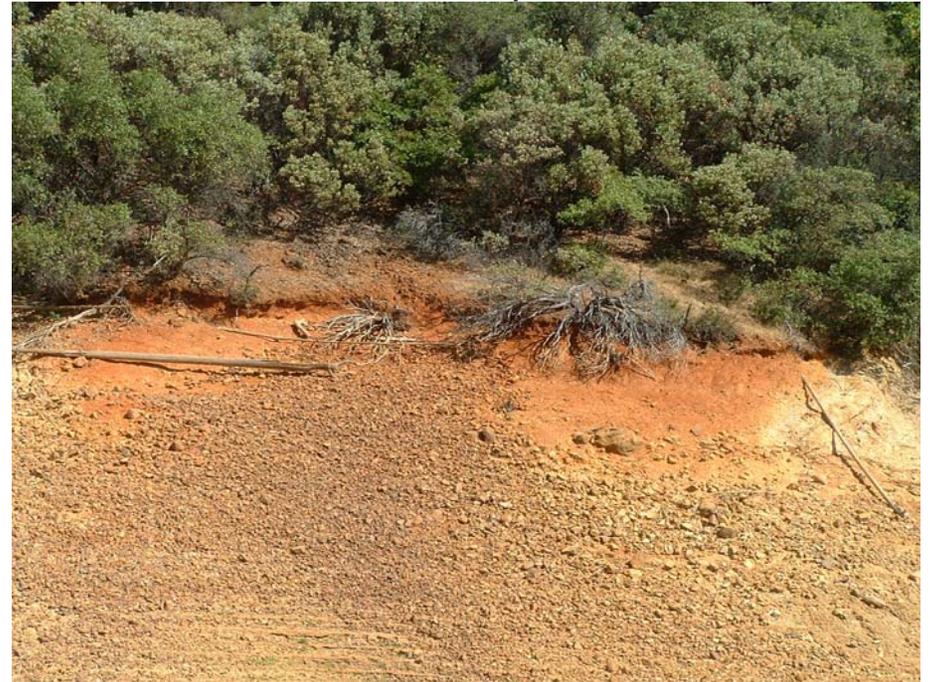
Photo Example 2

Low Severity Erosion

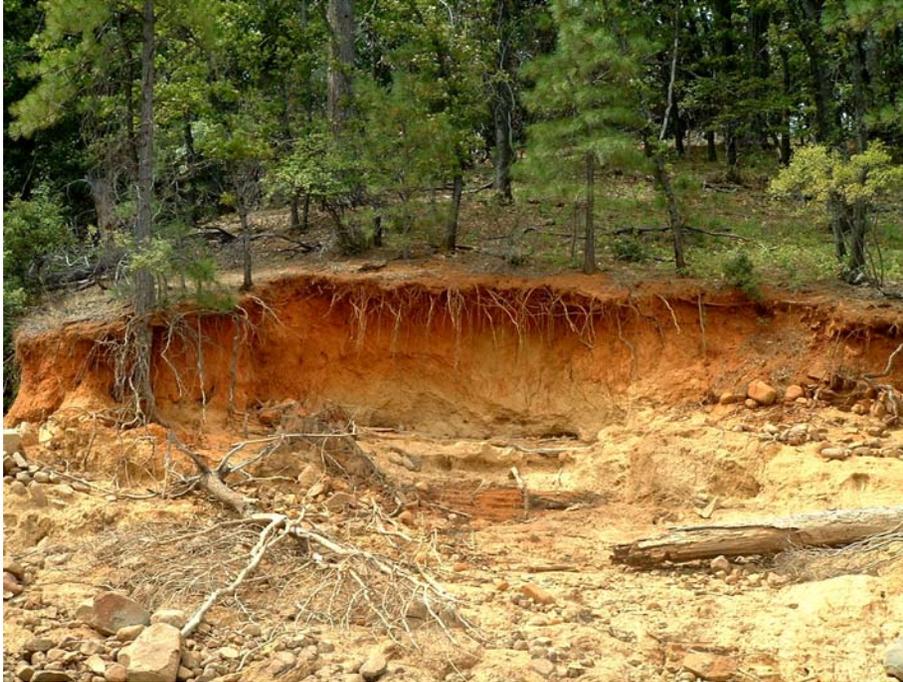
Photo Example 1

Moderate Severity Erosion

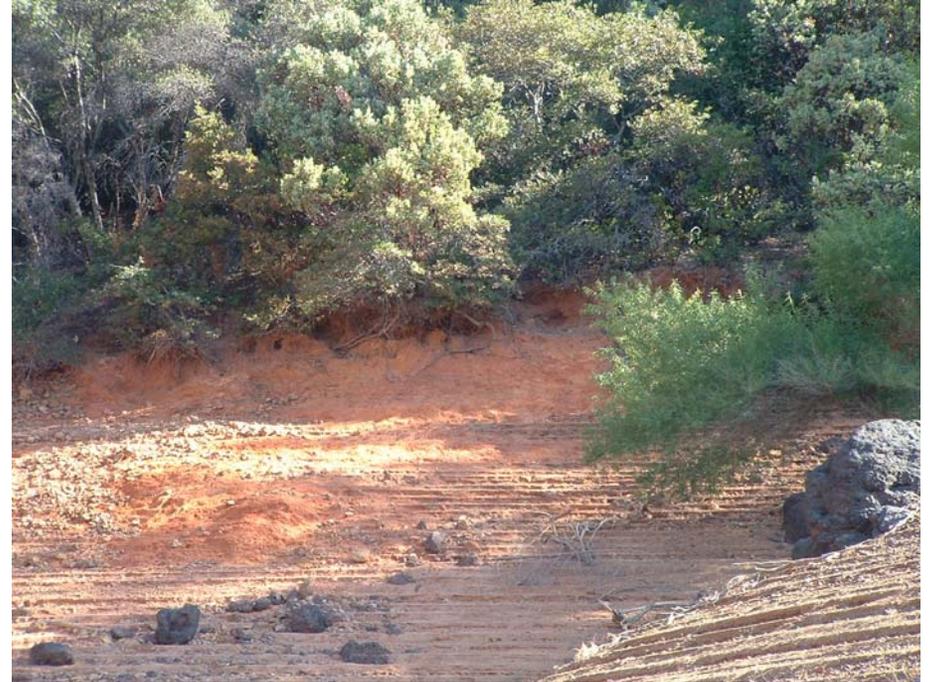
Photo Example 2

Moderate Severity Erosion

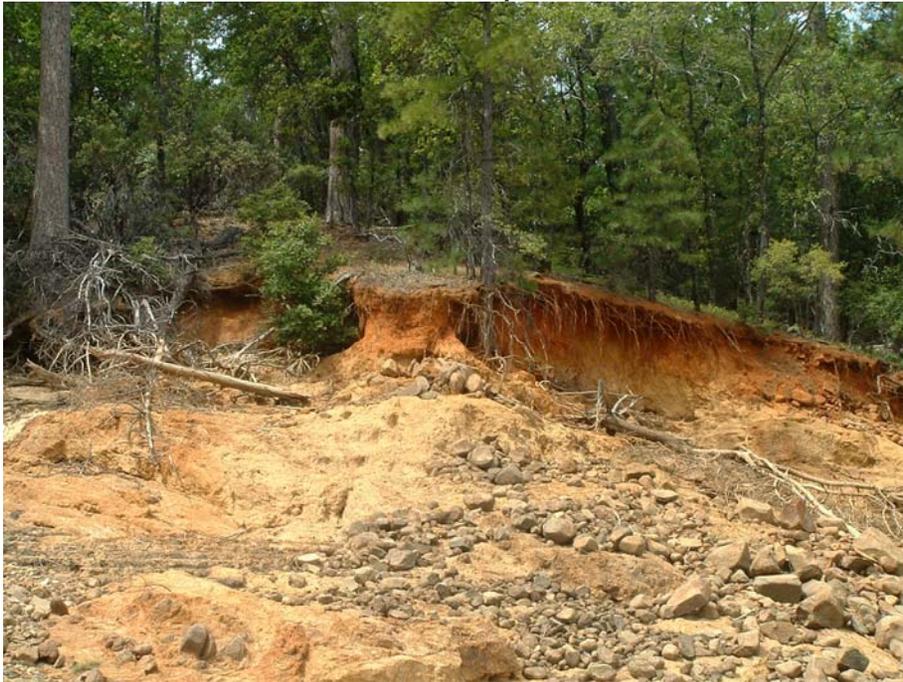
Photo Example 1

High Severity Erosion

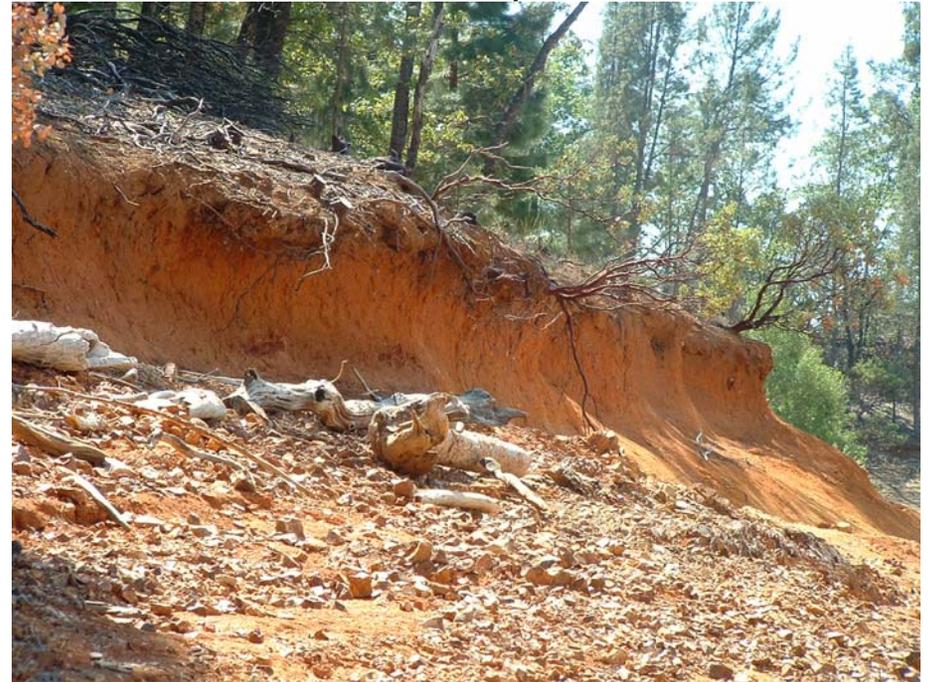
Photo Example 2

High Severity Erosion
