Bulletin 250

Fish Passage Improvement

An Element of CALFED's Ecosystem Restoration Program

June 2005

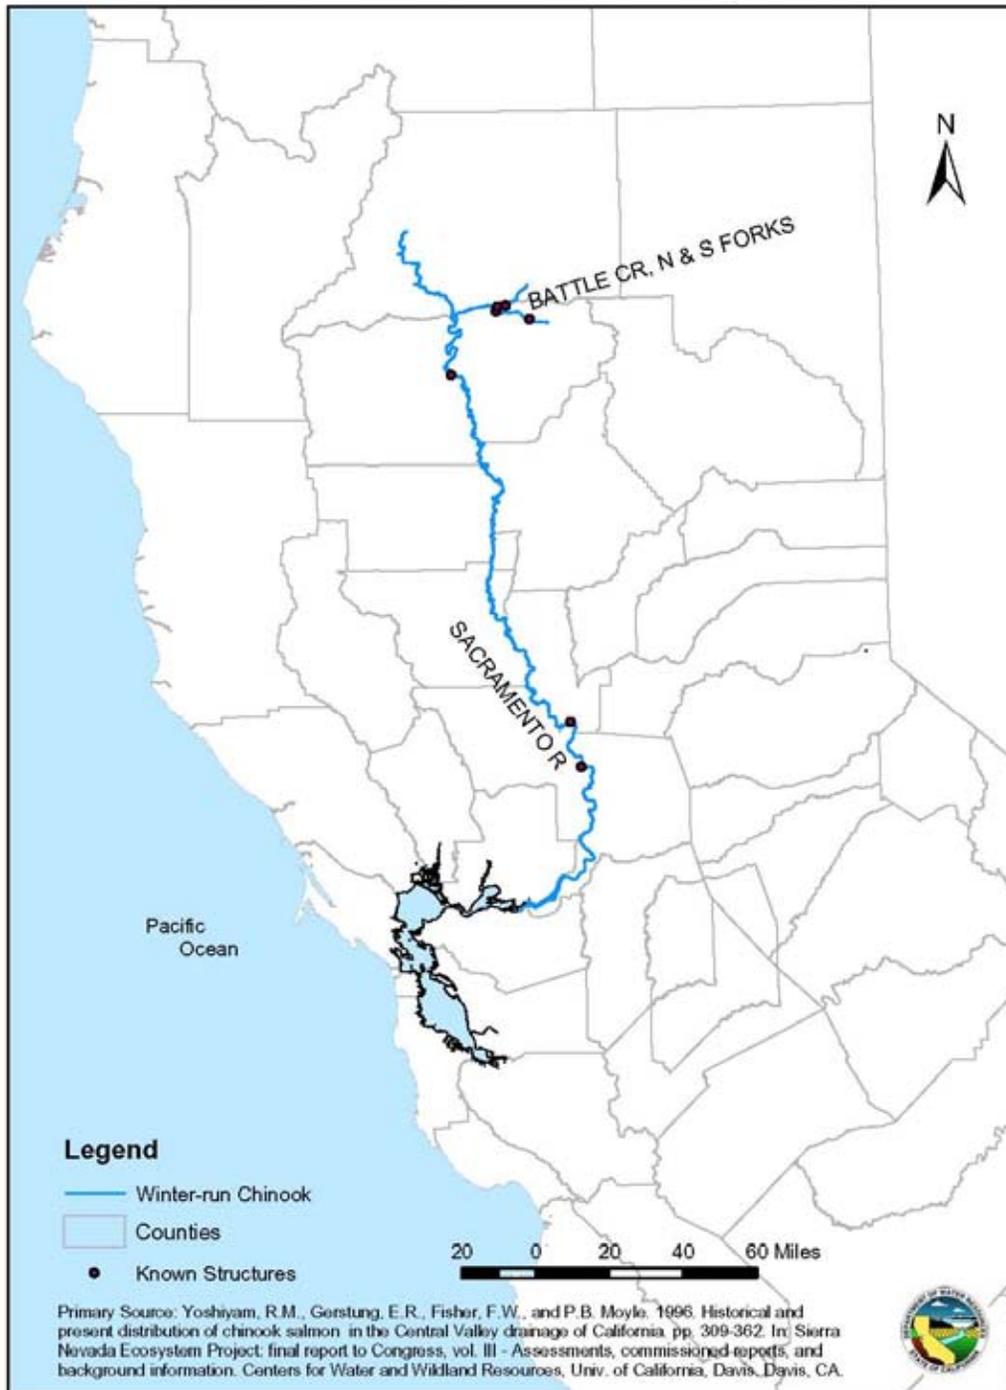
Figure 2-11 Known structures within the present range of winter-run Chinook salmon in the Central Valley of California

Note: This figure also appears in Chapter 4 as Figure 4-2 Known structures in critical habitat for winter-run Chinook salmon

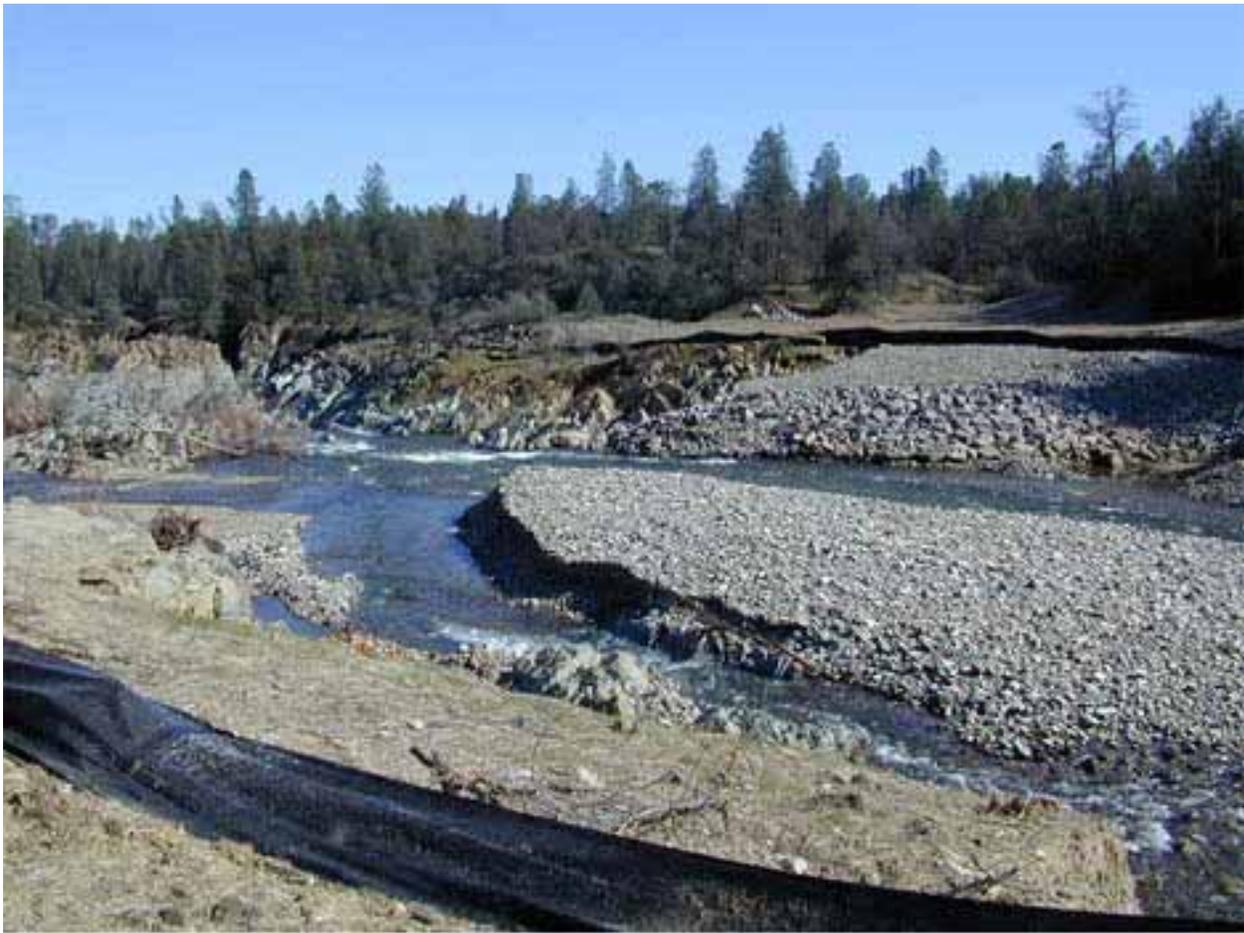
Photo 4-8 Clear Creek after removal of armored gravel berm
